Technical Bulletin

Doc No.: TN20-07
Version: 1.0
Date: 25 November 1998
Subject: Serial Communication problem on MC204 without Fibre-optic interface.

This bulletin is applicable to any MC204 supplied before the beginning of 1999 **WITHOUT FIBRE OPTIC** interface.

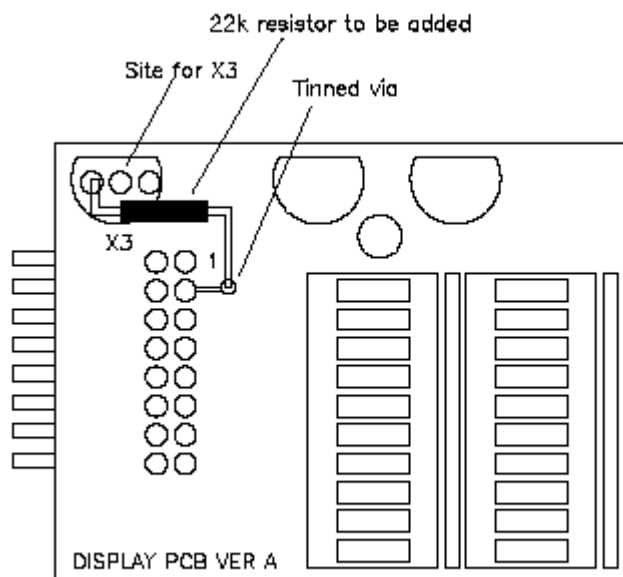
A problem has been identified which can cause occasional serial communications difficulties on port 0 and port 1 of the MC204 Motion Coordinator. *This problem only occurs on systems which are not fitted with the fibre-optic interface.*

It is also possible to easily modify an existing LED display by the addition of one through-hole resistor:

The resistor to be added should be approximately 22k 1/4W or 1/2W type.
