Doc No.: TN20-10
Version: 1.0
Date: 17 April 1997
Subject: Intermittent Power Up, Watchdog operation or Power Failure

*** MC2 ONLY ***

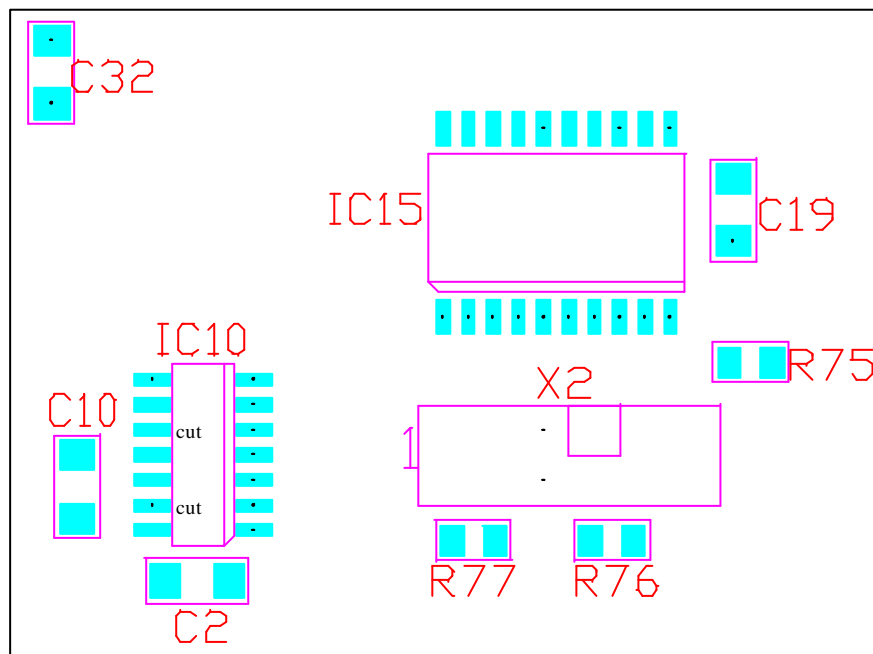
As a result of Trio's policy of continuous quality checks on all products shipped and any returned for repair a potential cause of premature failure has been discovered on a number of P110 (MC2) modules, version F or later. This problem potentially affects boards with serial numbers from MC2196 to MC2357 and P110-02358 to P110-02567 inclusive. According to our records you have received at least one of these boards.

If this modification is not carried out it is possible that the MC2 may exhibit various symptoms including intermittent power up or watchdog operation or a complete failure to power up. If these problems occur then the MC2 must be returned to Trio for further checks.

Two pins have to be removed from IC10 as shown on the diagram below. These are pins 10 and 13. To perform this operation it is necessary to remove the plastic bezel from the front of the module, followed by the top cover for the ribbon connector and the right hand side cover. See the manual for more details on assembly of the case. It is suggested that the pins are cut with a fine pair of wire cutters close to the plastic body of the IC and another cut made closer to the PCB to ensure that there is no chance of any remaining part of the pin making contact again.
