# Technical Bulletin

**Doc No.:** TN20-11  
**Version:** 1.0  
**Date:** 19 November 1998  
**Subject:** Battery loses voltage quickly \*\*\* MC1 ONLY \*\*\*

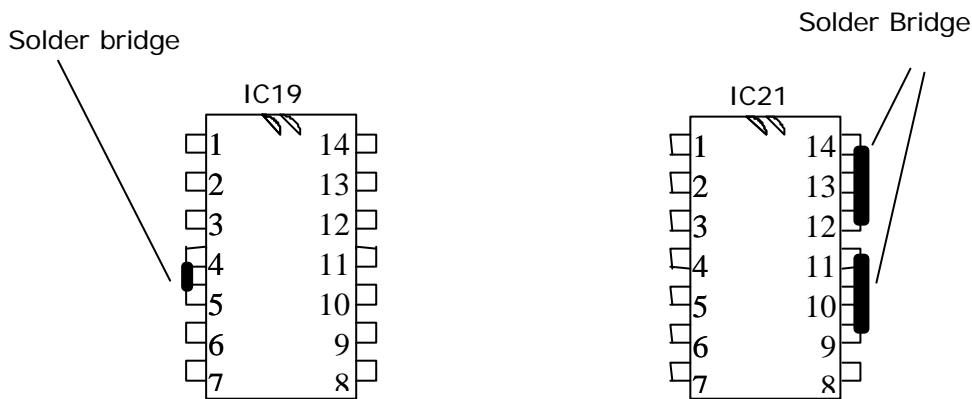
A number of early MC1's have been returned to Trio with problems caused by them quickly losing program and data held in battery backup. This has been found to have been due to a number of input pins on battery powered chips IC19 and IC21 not being tied to gnd or the power supply.

The problem is most easily rectified by connecting some of the pins of IC19 and IC21 to adjoining pins with a small bridge of solder. The battery is ideally replaced at the same time.
