**Doc No.:** TN20-46  
**Version:** 1.0  
**Date:** 28<sup>th</sup> Oct 2002  
**Subject:** Ver D Axis Expander Modification

## Technical Bulletin

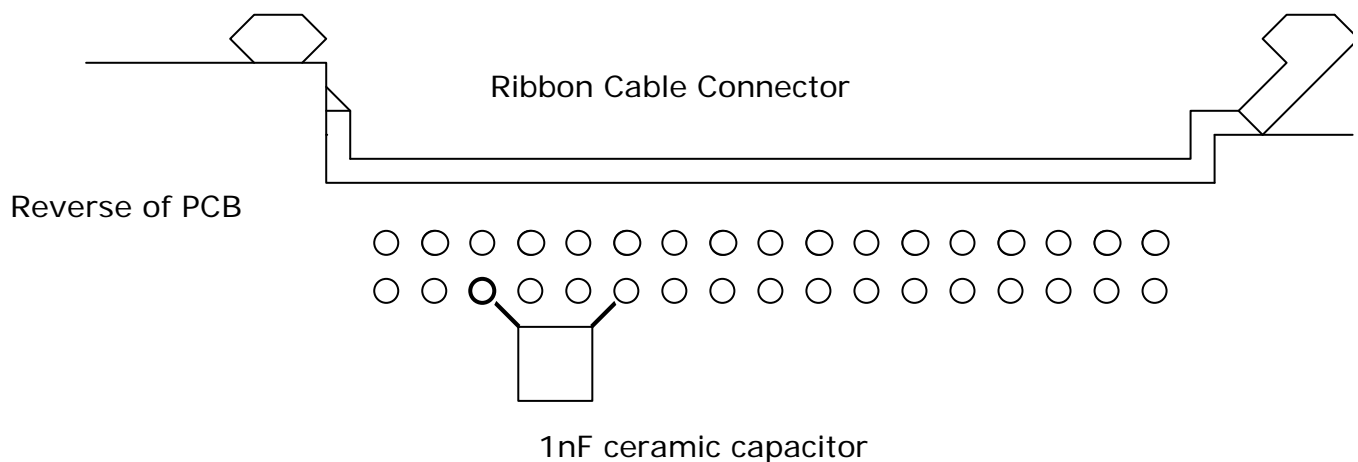
It has been found in one application, that where 3 axis expander modules are fitted on a system. Incorrect data may be read occasionally by the MC216/MC224 controller. The fault appears to be caused by very short noise pulses appearing on the RESET line of the ribbon cable bus. The fault can lead to incorrect movements on the axes under control.

Trio recommends that a 1nF ceramic cap is soldered onto all 3 version D axis expanders where they are used in applications requiring 3 axis expanders (See diagram). Future shipments from Trio will all include this modification. The capacitor can be fitted to all axis expanders without causing any detrimental effects. Version E PCB's will have the capacitor fitted on the PCB.

- Remove the PCB from the metal chassis.
- Solder a through hole 1nF ceramic capacitor between the pins illustrated.
- Ensure there is no possibility of short circuits
- Reassemble the chassis
