Doc No.: TN20-52
Version: 1.0
Date: 20th March 2003
Subject: P170 (MC224) and SLM compatibility Issue

Technical Bulletin

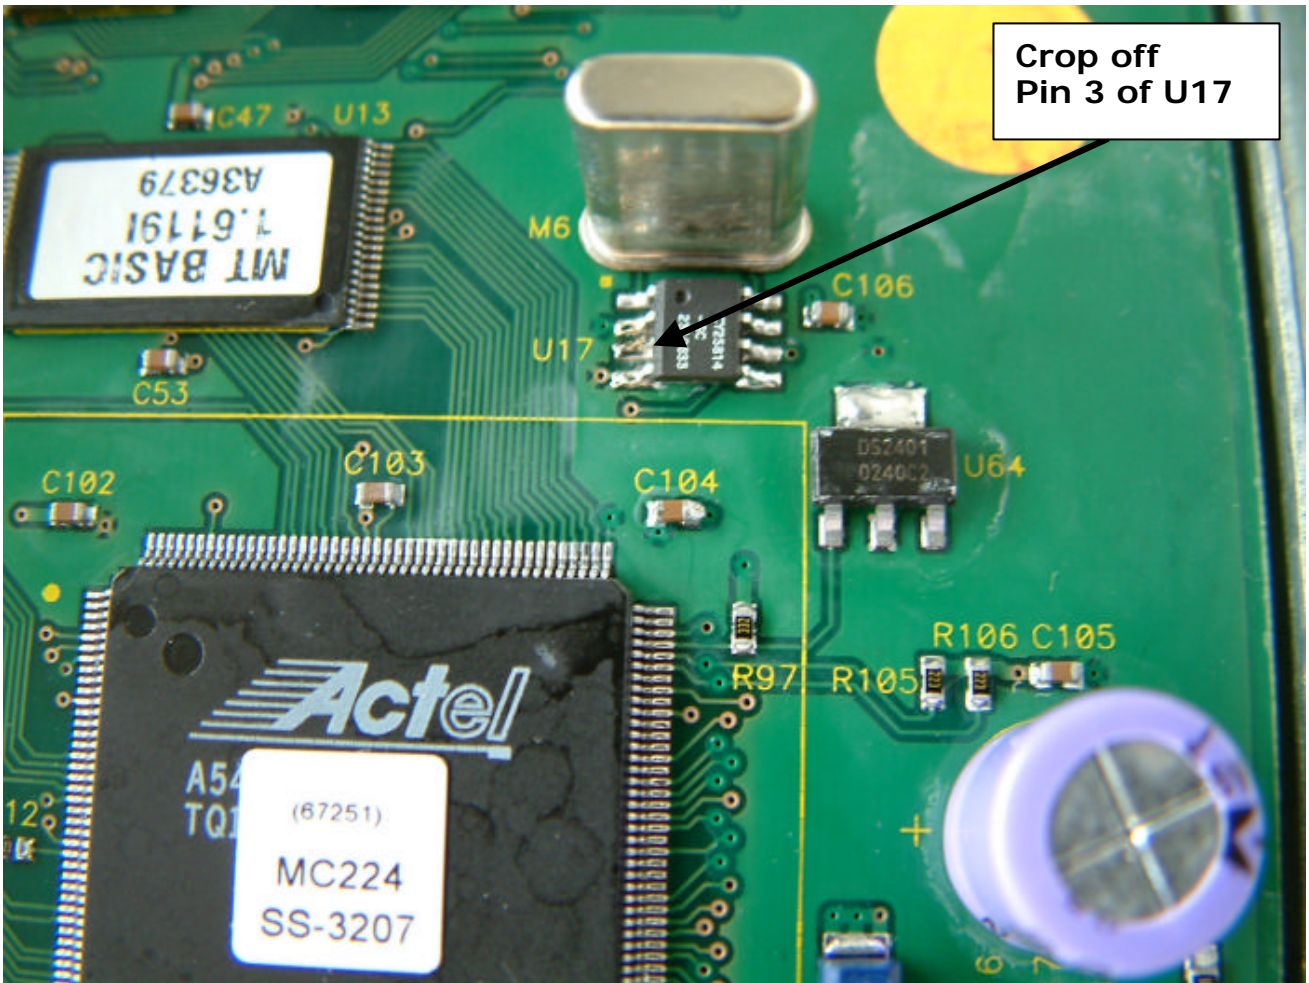
Fig 1: MC224 Main Board

Some systems using a P292 (SLM Daughter Board) in a P170 (MC224) have experienced transient position errors, usually denoted by a knocking noise as the motor runs. On some units the problem appears to be temperature related and the problem decreases in frequency as the unit warms up.

The problem has been caused by the accuracy of the sync signal fed into the DriveLink^{MD} ASICs on the P292 from the P170. The system clock on the P170, like other Trio controllers, is generated by a spread spectrum frequency modulator to improve EMC performance by spreading the bandwidth of the clock by a small amount, thus reducing peaks in emissions from the product. A new device has been used on the P170 to generate the clock so this problem will not affect other products. The particular configuration of this device used on the P170 has resulted in the 1ms sync signal actually occurring every 999.2us to 999.4us.

For boards already in the field a simple change can be made to the P170 to improve the accuracy of the sync signal. By isolating pin 3 of U17 the spread of the clock is reduced and the 1ms sync signal is brought within a range that will work reliably with the DriveLink^{MD} ASICs. The trade off is a possible increase in emissions. Comparative checks were made between a modified and unmodified board and no significant increase in emissions was seen.

The easiest way to affect this change is to crop the pin of the IC as shown overleaf:

This work can be carried out, free of charge, by Trio if the unit is returned to the nearest Trio office or by the customer in the field if it is more convenient.

When the modification has been done, the system software must be updated to 1.6126 or later.
